Corrosion Immersion Testing of 13-mm-Diameter Grade-10.9 Bolts for Bolt-on Armor

ARL-CR-654

July 2010

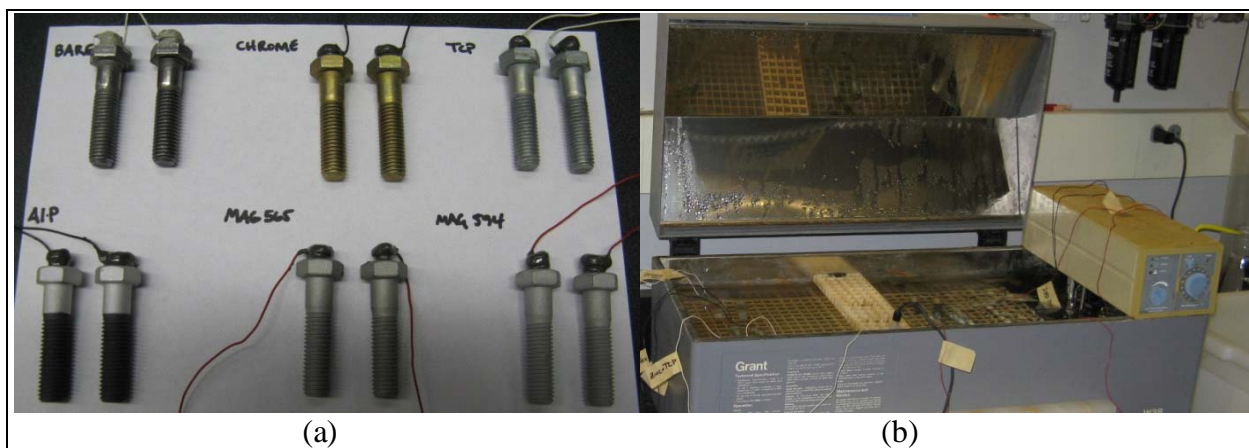
Figure 2. (a) Prepared bolts prior to immersion and (b) immersion bath setup.

1. Each bolt had a 1/8-in hole bored into the center of its head (see figure 1).
2. A Zn-plated steel screw, wrapped with wire, was fixed in place using this hole.
3. Polysulfide sealant was used to insulate and seal the wire/screw assembly to the bolt to prevent contamination (see figure 2 for full assembly).
4. A thermostatic circulated bath was filled with a 5% NaCl solution and heated to 75 °F. Solution temperature was maintained for the duration of the experiment, and the water was continually agitated.
5. Two of each specimen were immersed in the bath for 500 h. Open circuit potential measurements and visual inspections were taken after 1, 2, 4, 8, and 24 h, and every 24 h thereafter.

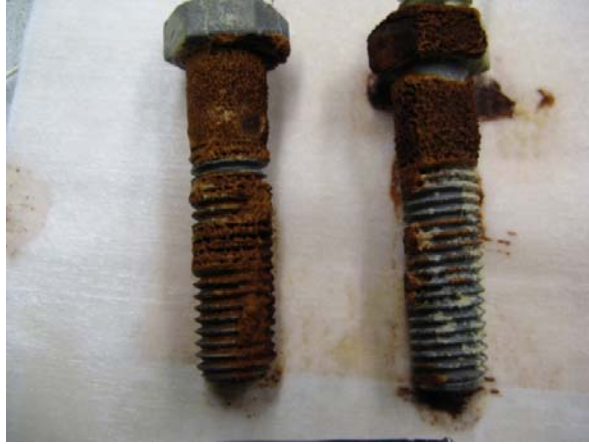
Figure 5. Bare bolts immediately after immersion.

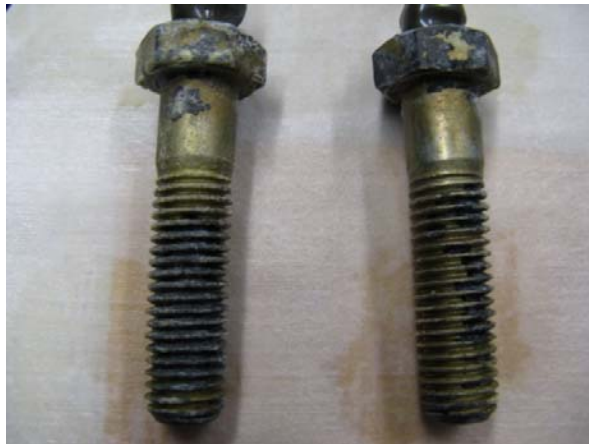
Figure 6. Hexavalent chrome/zinc bolts immediately after immersion.

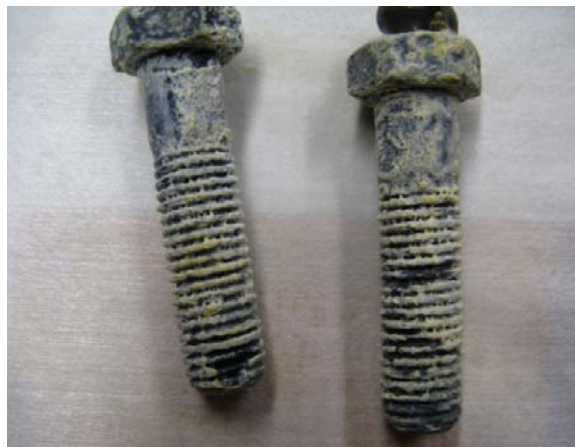
Figure 7. TCP/zinc bolts immediately after immersion.

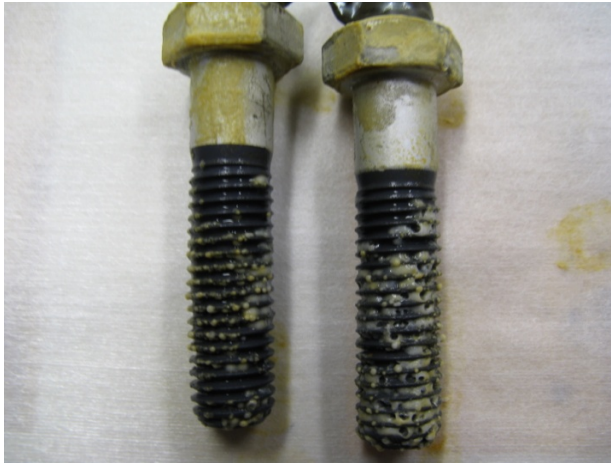
Figure 8. AlumiPlate bolts immediately after immersion.

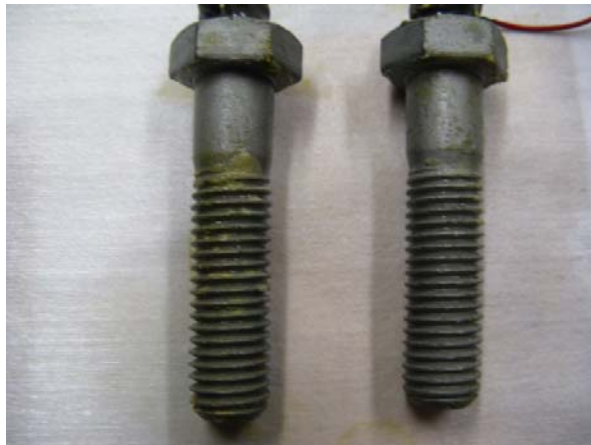
Figure 9. MagniPlate 565 immediately after immersion.

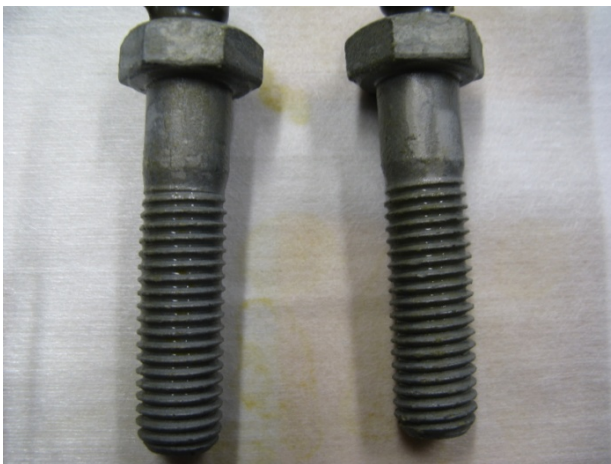
Figure 10. MagniPlate 594 immediately after immersion.

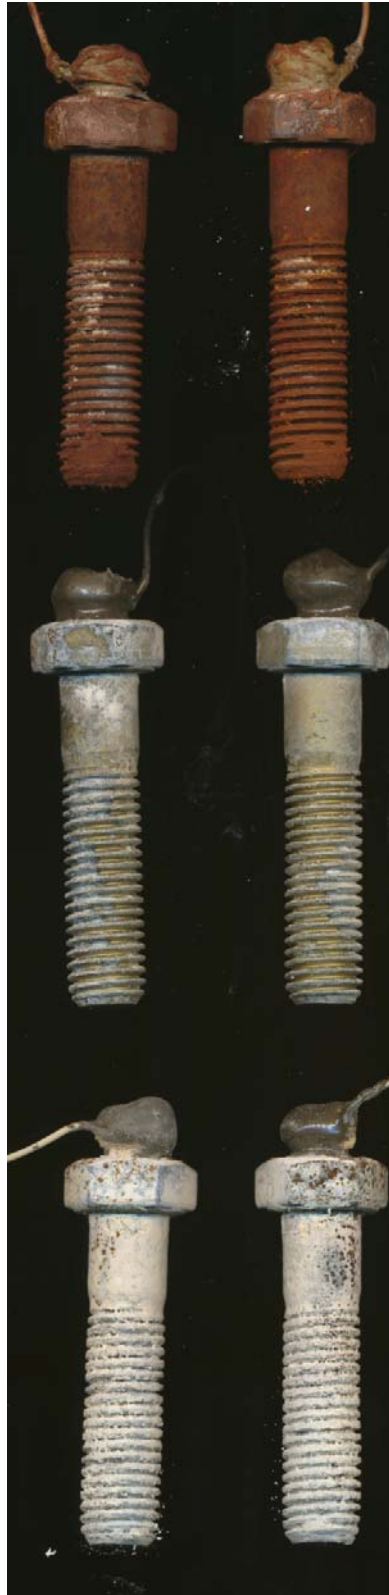
Figure 11. Bare steel, hexavalent chrome/zinc, and TCP/zinc after drying.

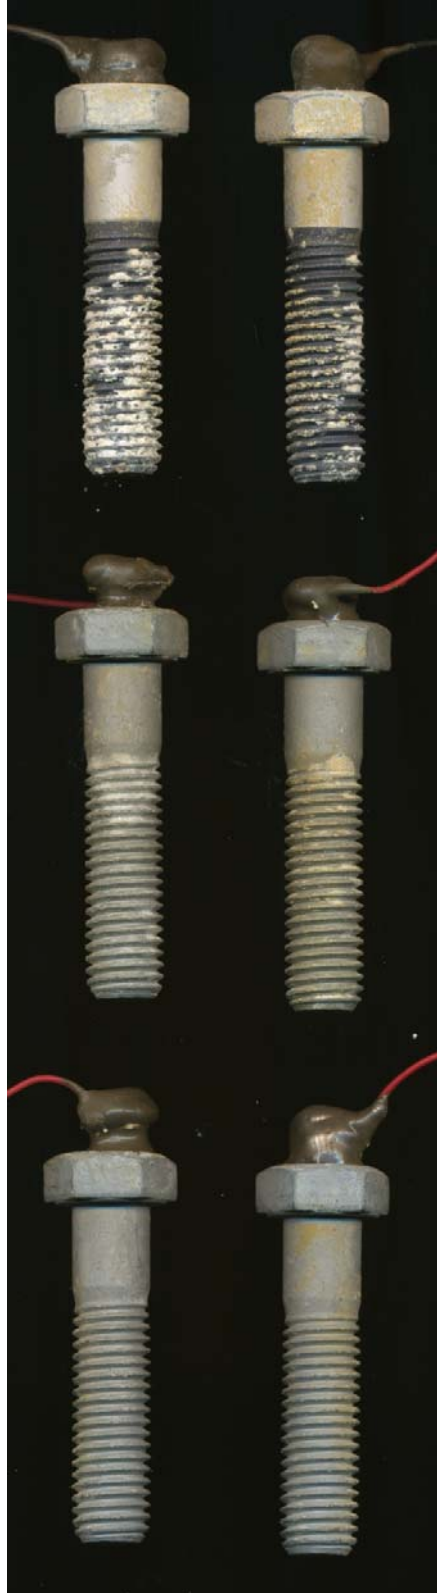
Figure 12. AlumiPlate, MagniPlate 565, and MagniPlate 594 after drying.

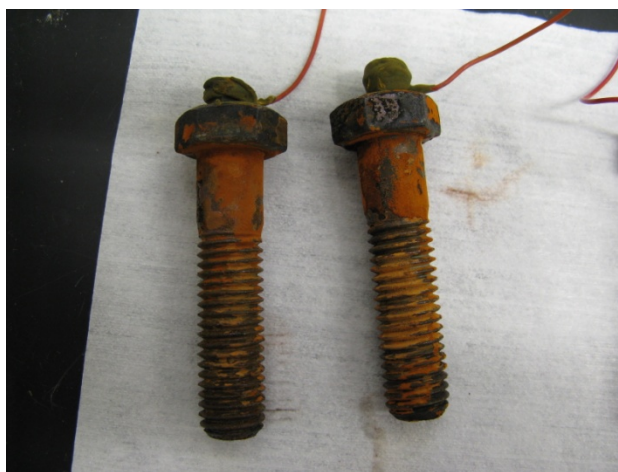
Figure 15. Bare bolts immediately after immersion in supplementary experiment.

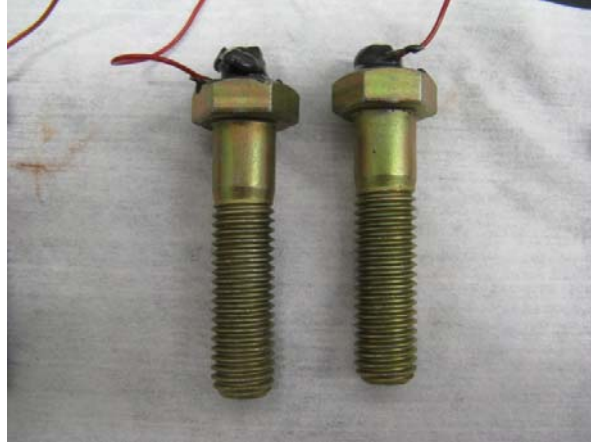
Figure 16. Hexavalent chrome/zinc bolts immediately after immersion in supplementary experiment.
